# Manhole Inspection Summary

Manhole # S27C\_\_021MH

Insp Date: **12/4/07 3:27 PM**

**Location** Address: **901 BENNETT-FRANKLIN AL** Cross Street: **FREMONT AVE**

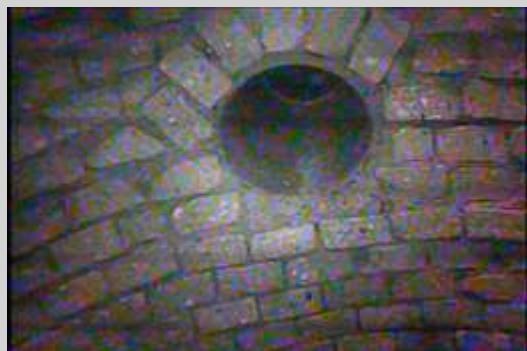
6 O'Clock Inflow

Pipe Height: **8.4** (in.) Rod and Bar (Angled)

Pipe Material: **Clay** ☐ Pipe Lined

Infiltration: **None** Pipe Seal Cond: **Sound**

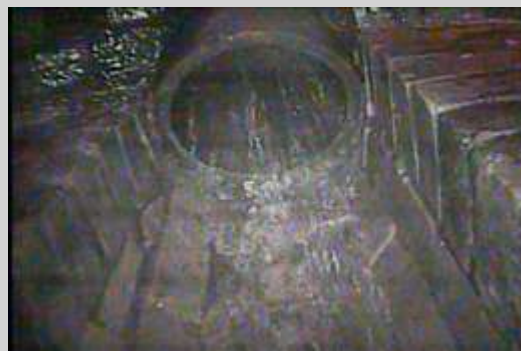
Drop In @ 6 O'Clock

Drop Condition: **Open**
